# M.2 Interoperability Warning

## Executive Summary

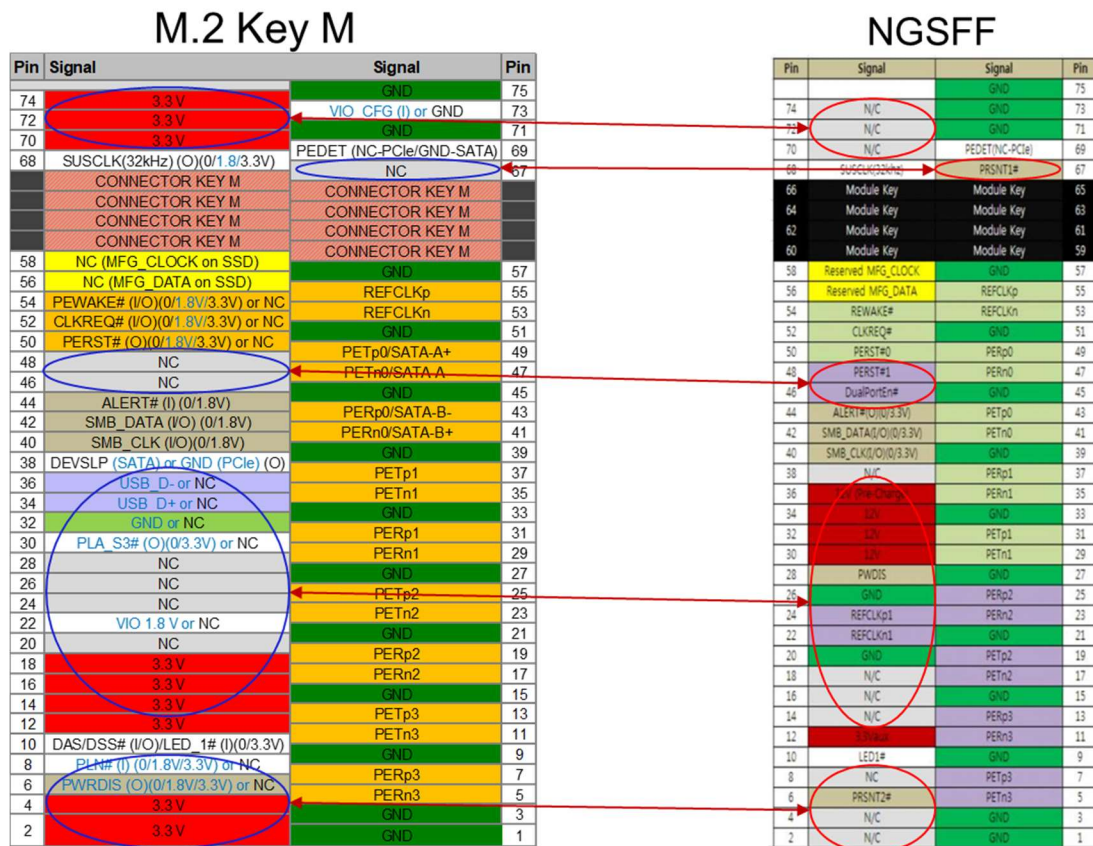
Figure 1: M.2 (Left) and NGSFF (Right) Pin Assignments with Differences Circled

- Potential M.2 host damage due to high current placed on M.2 host CMOS output - Pin 6 of M.2, PWRDIS, will connect to NGSFF PRSNT2#
- Potential M.2 host damage due to 3.3 V on M.2 host shorting to adjacent NGSFF Add-in Card Ground (pin 18 to pin 20).
- Potential M.2 Add-in Card and NGSFF host damage from shorting 12 V to Ground - Pin 32, M.2 Ground, will connect to NGSFF 12V.
- Potential end user impact/confusion from non-functioning devices - NGSFF Add-in Card not working in M.2 host system due to limited 3.3V on NGSFF.
- Potential NGSFF Add-in Card damage due to high current placed by M.2 host - pin 12, 3.3V power, will connect to NGSFF 3.3V Aux.
- Potential NGSFF Add-in Card damage due to out of spec voltage placed on one Add-in Card input signal - Pin 22, M.2 1.8V, connected to NGSFF REFCLKn1
- Unknown future issues due to NGSFF using 5 pins that M.2 may use in the future.

M.2 specifies pin 6 as PWRDIS (host output), and NGSFF specifies it as PRSNT2# (host input). If PRSNT2# is directly grounded on the NGSFF AIC, then the M.2 Host's PWRDIS pin will connect straight to ground. Though M.2 does not specify a maximum current, this atypical usage can result in I/O buffer electrical overstress, and potentially could cause permanent damage the M.2 host signal. Further, NGSFF specifies its PWRDIS functionality on a different pin 28, thus creating unnecessary duplication and complexity.

M.2 specifies pin 22 as a 1.8V power source (VIO 1.8 V), and NGSFF specifies it as REFCLKn1 (AIC input). If the NGSFF AIC supports PCI Express, then when an NGSFF AIC is inserted into an M.2 host, the M.2 host will drive 1.8V onto a pin that expects an absolute maximum input voltage (Vmax) of 1.15V. The increased voltage could damage the NGSFF AIC reference clock logic.

M.2 specifies that a host provide 3.3V of power across the above pins, and NGSFF specifies only 3.3Vaux on one of these pins (NGSFF specifies that a host is to provide 12V of power across a different set of pins). If an NGSFF AIC is inserted into a M.2 host and the NGSFF AIC does not draw more than the maximum M.2 pin current limit, then due to insufficient power the AIC might not power up or function correctly. If the NGSFF AIC draws more than the maximum M.2 connector pin limit, then the M.2 connector pin could be overstressed which could result in damage to the M.2 host and/or the NGSFF AIC.

M.2 specifies pin 30 as PLA-S3# (host input), pin 32 as GND, pin 34 as USB D+ (host output), and pin 36 as USB D- (host output). NGSFF specifies pins 30, 32, and 34 as 12V and pin 36 as 12V pre-charge. If an M.2 AIC is inserted into an NGSFF host, then 12V power would be connected to USB D+, USB D-, and GND. If an NGSFF host is unable to discern an M.2 AIC, then the NGSFF host and M.2 AIC could be damaged.

M.2 specifies pin 20 and pin 26 as NC, and NGSFF specifies these as GND pins. If an NGSFF AIC is inserted into a M.2 host, then NGSFF AIC pin 20 would be located next to M.2 host pin 18 (3.3V power pin). If these pins were to make contact for any reason, then the M.2 host and NGSFF AIC could be damaged. To prevent such damage, M.2 and other industry standards do not locate power and ground pins where they could make contact. Further, since pin 20 and 26 are NC pins, future M.2 specifications will make use of these pins for other purposes.

M.2 specifies pins 46, 48, and 67 as NC, and NGSFF specifies these as DualPortEn#, PERST#1 and PRSNT1#. Future M.2 specifications will make use of these pins which could result in interoperability problems or damage.
